## TOWN OF NEWTOWN

32 Riverside Road (Sac Field)  
Sandy Hook Permanent Memorial Site  
Pond Study

Study By: George Benson - Director of Planning  
Steve Maguire - Senior Land Use Enforcement Officer

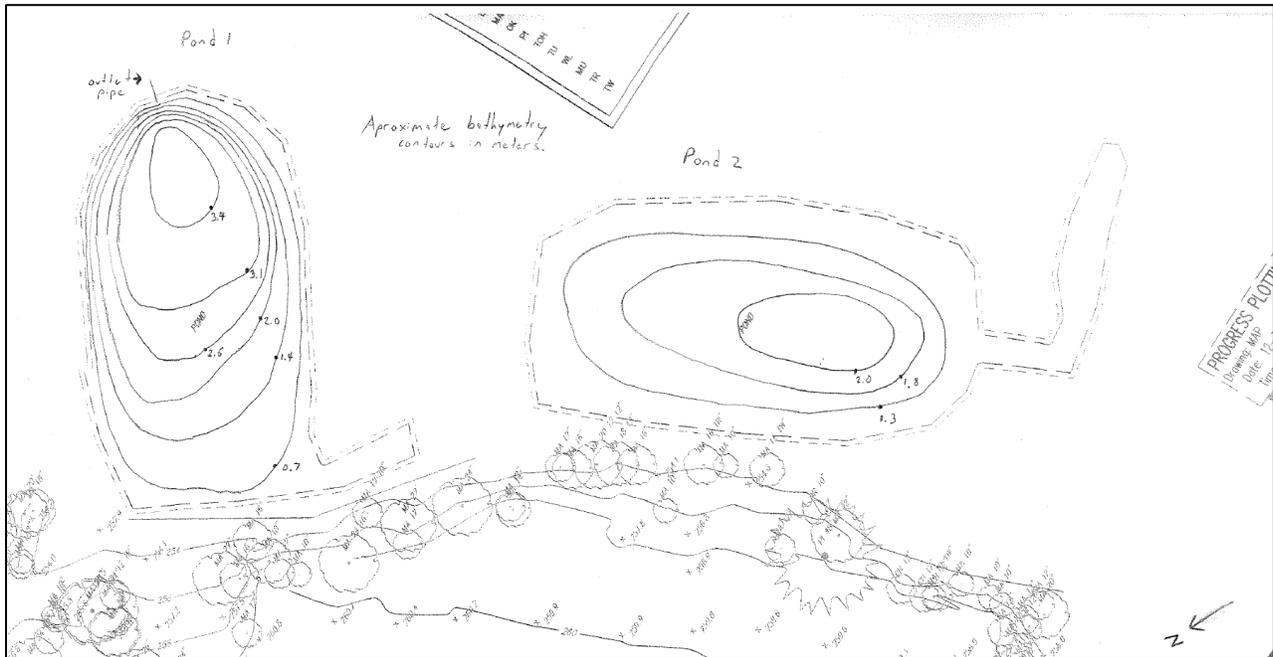
## Bathymetry Map

Pond One (the eastern-most pond) and Pond Two, to its west, are tannic and dystrophic, meaning very acidic (6.5 and 6.7 Ph), tea-colored ponds. It is believed that the ponds occurred during excavation for gravel in the 1930s when the digging reached the ground-water level. Their color and acidity are attributed to the lack of flow in and out, as well as the quantity of leaves and other organic matter that decompose in the water. The nutrient levels in the water are relatively high because there are few organisms present that would utilize the phosphorus and nitrogen. The ammonia levels are relatively high due to low levels of oxygen in the water, Pond 1 is approximately 3.4 meters deep while Pond 2 is approximately 2 meters deep.
